Comparing the impact of two bottom trawls

Part of the EU project **DEGREE**
(Development of fishing Gears with
Reduced Effect on the Enviroment)

**DEGREE Periodic Activity Report No 2
Annex 3.1.x**

**Report from a cruise onboard RV G. O. Sars 22.10 –
03.12.2008:**

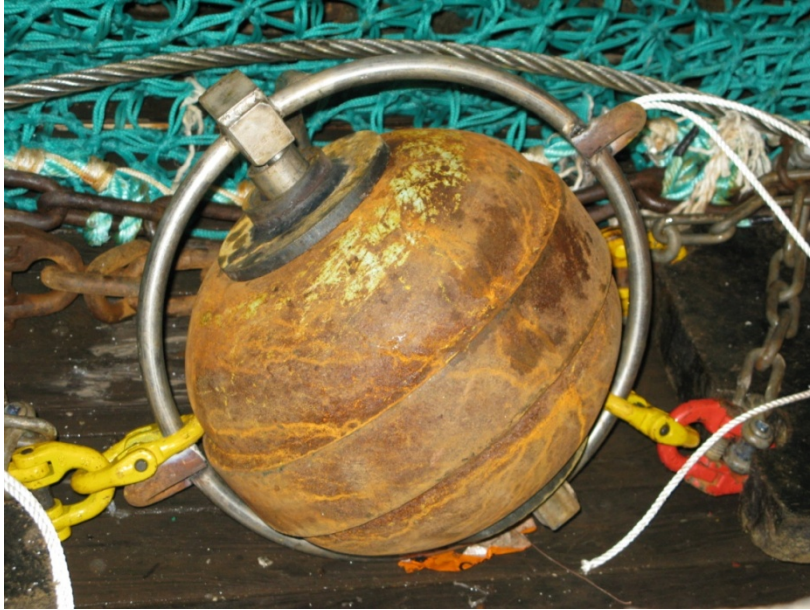
Figure 12. One of the bobbins specially designed to always roll in the towing direction of the trawl.

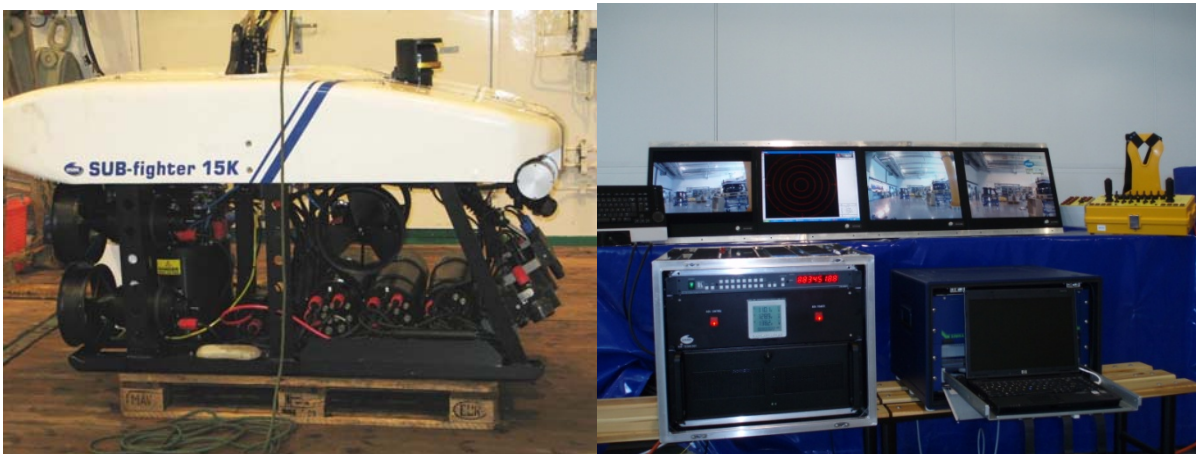
Figure 13. The ROV Subfighter 15K (left) used for bottom habitat mapping. The right picture shows the surface control equipment and observation screens.

The ROV was fitted with a HIPAP positioning system which enabled communication between the ROV and the DP (Dynamic Positioning) system of the vessel. During ROV surveys the vessel was set in “follow target” modus, so that the movements of the ROV controlled the movements of the vessel. Navigation data from the vessel and ROV was stored using NaviPac format.

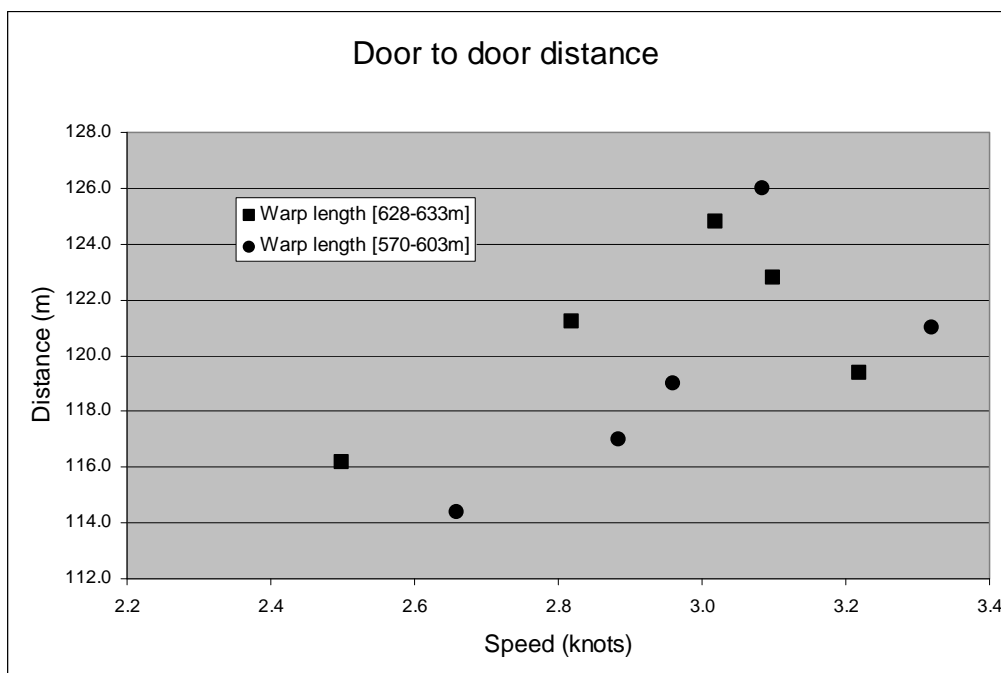
Figure 17. Distance between doors against speed over water for 2 warp length classes

The door to door distance is represented on Figure 17. The distance increases till a speed of about 3 knots and then decreases at higher speed. This is caused by the effect of doors lifting off the bottom and trawl drag increase. The optimal speed regarding the door efficiency used with this plate gear trawl seems to be around 3 knots. We can also observe a usual result : average door distance increases with warp length. However the relative variation of door distance with speed and warp length is rather low : maximum 10% in the ranges considered.

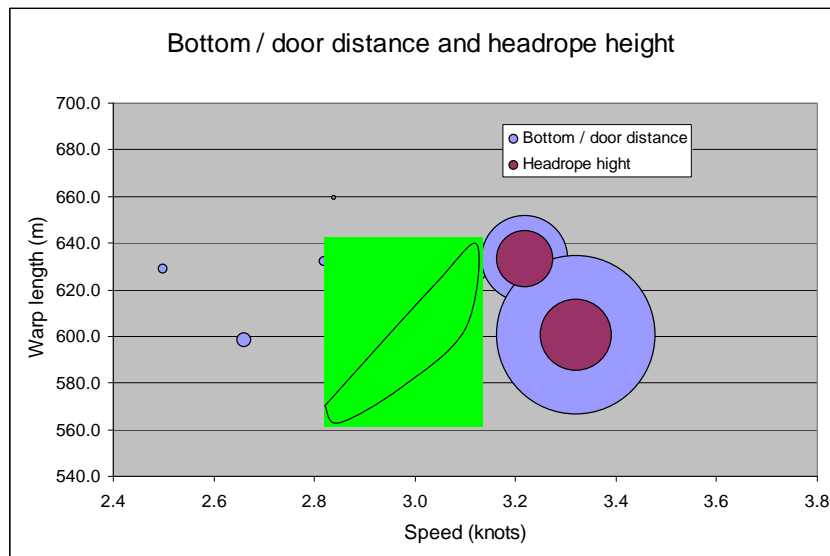
The diameter of blue bubbles directly equals averaged door to bottom distance. The diameter of red bubbles is calculated in order to amplify the gap between the average headrope height in normal fishing conditions for this trawl (4.4 m, Figure 18) and the height of headrope in the case of speed too height and/or warp length too short.

The “good combinations” can be found on Figure 19 where we have a big blue bubble and no or almost no red bubble. These points are underlined in the Figure in the green area.

Figure 19. Door height and headrope height as a function of warp length and speed over the water

We can conclude from these trials that light fishing with doors off the bottom and ground gear on the bottom can be achieved using speed over water in the range [2.9 – 3.1] knots and warp length in the range [570 – 630] m. These combinations are only for average depths in the range [200 – 230] m.

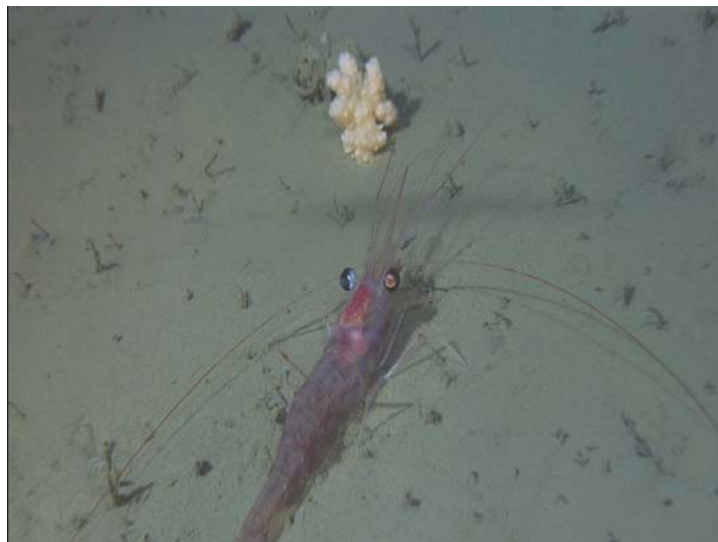
Figure 21. A typical bottom in the experiment area with the tubes of sedentary polychaeta protruding from the sediments. In addition a octocoral (Anthozoa) and a shrimp (*Pandalus borealis*) can be seen.

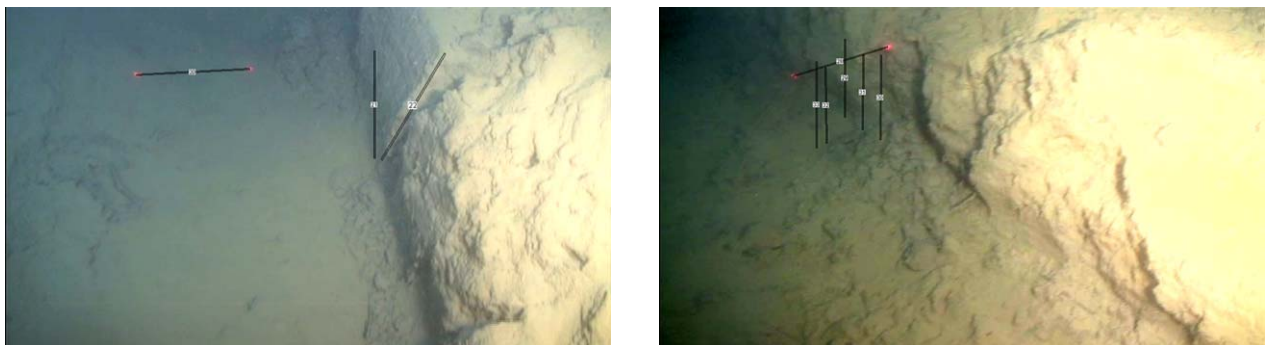
Only the rockhopper trawl had doors touching the bottom (Figure 23). Initially we strived to make the doors of the plate gear barely touch the bottom, believing that it was difficult to lift the doors while simultaneously keeping the door spread. The initial hauls inspected with the towed vehicle Focus showed, however, that the doors were lifted a short distance from bottom while the trawl configuration was maintained. The lifting was confirmed during the ROV observations of the trawl paths. No tracks could be seen from doors in the path of the valid plate gear hauls. In the track of haul no 355 where the plate gear trawl by mistake was run with longer warps (700 m instead of 600 m, i.e. as long as in rockhopper hauls), deep furrows from the doors were found.

Figure 23. Tracks of door from the rockhopper trawl. The black bars shows measurements done to size the track. The distance between the red laser lights was 10 cm.

One interesting observation was that the doors did not seem to follow a steady track on the bottom. The depth of the door path varied, and also the amount of aggregated mud within the path. It seemed that the mud aggregated in front of the door while towed along until the dung of mud reached a certain size/weight. Then the door seemed to flip over the sediment pile, and stay floating above the bottom for some meters. It thereafter landed on bottom, started to dig into the mud and build up a new sediment pile, and a new cycle started.

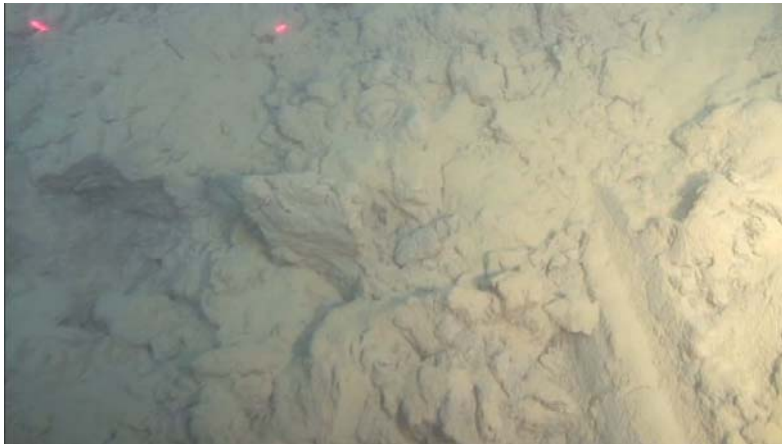
Figure 24. A pile of mud sediment deposited by a trawl door on the rockhopper trawl.

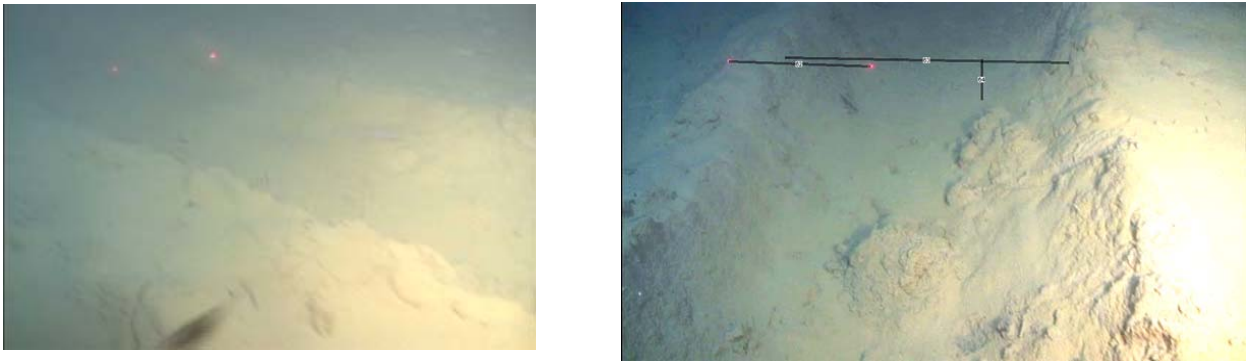
The different parts of the sweeps were linked with steel or rubber discs (see Figure 4), which made clear tracks on the bottom (Figure 26). These tracks had an average cross section of between 15 and 25 cm, and were more or less identical on both trawls.

Figure 26. Two tracks from bobbins on the sweeps. Black bars are used for measuring of tracks. The distance between the red laser points is 10 cm.

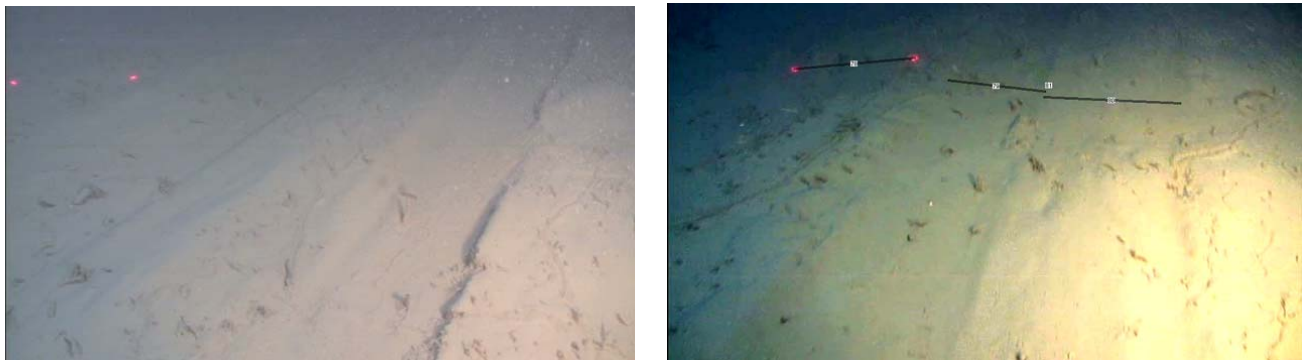
Figure 29. Tracks from plates on the sea bed.

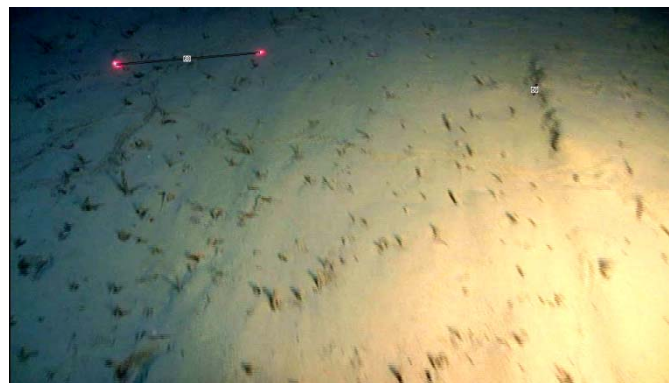
In some areas the tubes of *Spiochaetopterus* could be seen protruding from the sea bed more than in the control areas, obviously exposed by the passage of the ground gear (Figure 30).

Figure 30. Tracks from plates of the plate gear. Tubes from tube dwelling polychaets has been exposed by removal of sediments.
